Tree Hazard Evaluation

For Kinleigh Folkard & Hayward

Ashworth Mansions, London W9 1LN

Job Reference: 02337R

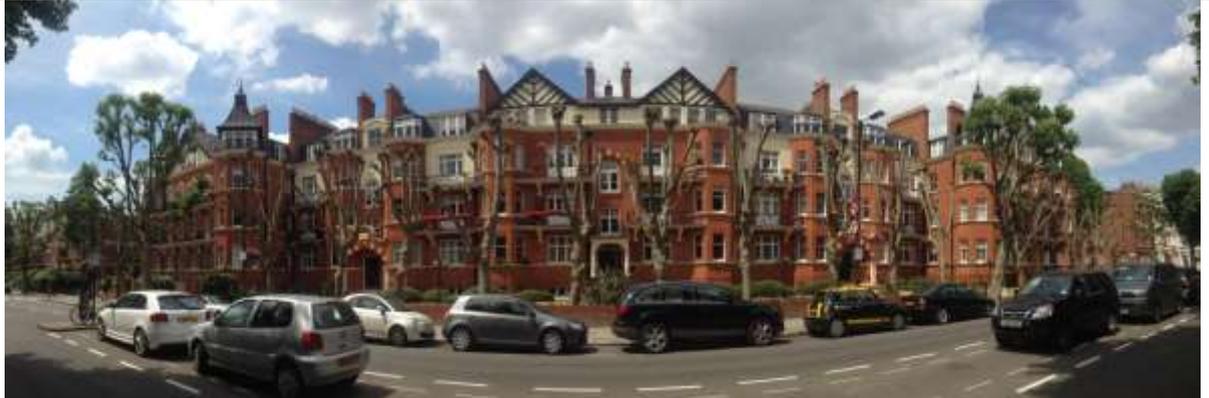
These trees are an amenity feature planted at the time the building was constructed. They are visually prominent to Elgin Avenue. They have a long history of being managed as pollards. As a species London Plane is very tolerant of such pruning work. Most of the trees have small pockets of decay on the main stem associated with a history of pruning works. In places this decay is well established but given the cyclical repeat pruning undertaken (which reduces the wind resistance presented by each tree and therefore leverage on the weak pruning areas) we would envisage few issues with the associated decay.

T17 – T33 (London Plane) and Ashworth Mansions (Front)

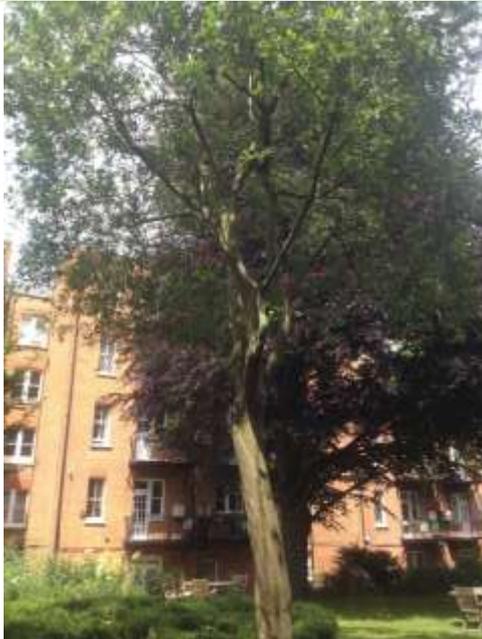
T1 Goat Willow

Tree No.	Species	Height (m)	Age Class	Past Management	Defects	General Comments	Risk Target & Year of Next Inspection	Tree Works	Work Priority
T1	Willow (Goat)	8	Mature	No significant recent management	No Gross Defect Noted	Lower branches previously removed. Evidence of Ganoderma spp developing at crown break and also at 1.2m	Low (2020)	No works	NA
T2	Beech (Copper)	15	Mature	No significant recent management	No Gross Defect Noted	Minimal previous pruning history. As a species it does not tolerate severe pruning. Included Union at crown break. Vigilance for <i>Meripilus giganteus</i> always advised with mature examples of this species.	Medium (2018)	No works	NA
T3	Maple (Silver)	12.5	Mature	Subject to previous pruning	No Gross Defect Noted	This tree has been topped at 6m previously and the canopy has fully regrown. There is a genuine risk of sections of regrowth breaking out. The buildings do shelters the tree but cyclical reduction work should manage this structural defect. This appears in place with further reduction points high in the main canopy.	Medium (2018)	Crown reduce by 2-3m and repeat at 5 year intervals	12 months

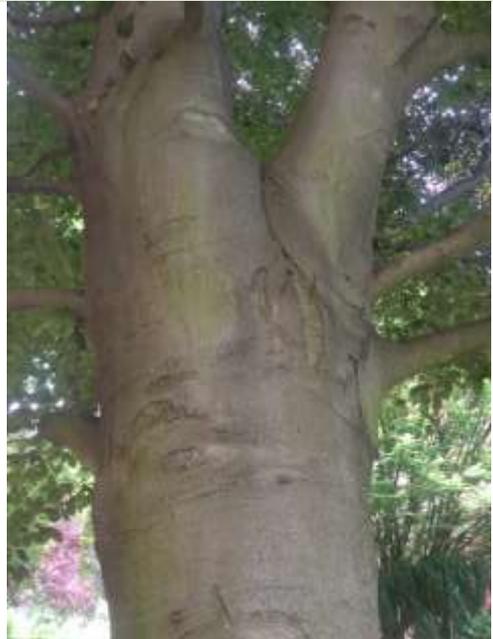
This is a mature specimen and as is usual for the species it has a number of included unions evident on the main stem. These are generally considered weak areas but this does not mean they will ultimately fail. The tree appears to have been pruned back from the adjacent building and possibly the subject of other light pruning in the past. As a species Beech do not tolerate significant crown reduction or thinning works. Generally it is advised to keep pruning to a minimum for this species. 2 main fungi are associated with Beech. [Ganoderma spp](#) which causes a perennial fruiting bracket (of which none were visible) and [Meripilus giganteus](#) which generally appears at the base of an infected tree between July-September. Both fungi are generally obvious by virtue of their size and in the event either should appear we should be contacted for further advice.

T2 Beech – showing included union at crown break

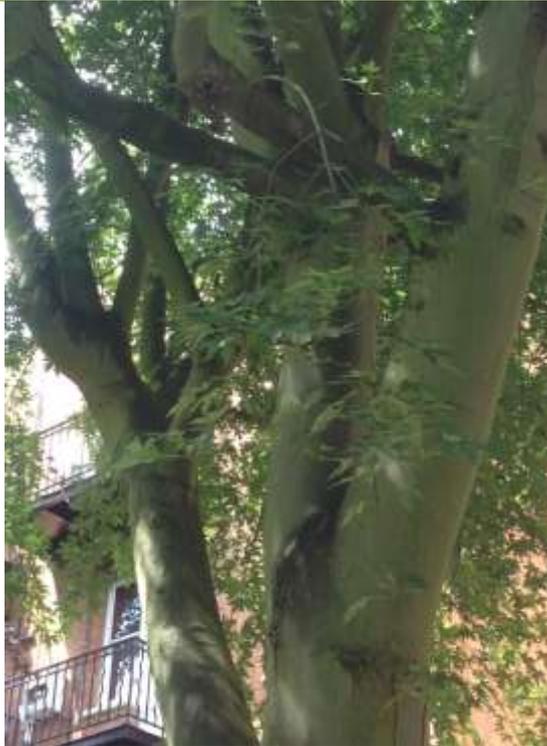
These 2 trees have both been significantly reduced in the past (>20 years previously) and the canopies have fully regrown. They have then been subject to further crown reduction works limited to the outer 2-3m of the canopies. The original reduction works has introduced a long standing weakness on each tree but subject to the outer canopy reduction (to reduce leverage on the lower weakness as the previous pruning will have introduced some decay) being continued on a cyclical basis the trees should pose no significant health and safety concerns. As a species Silver Maple is tolerant of pruning.

T3 Silver Maple – showing V unions and areas of previous pruning

Tree No.	Species	Height (m)	Age Class	Past Management	Defects	General Comments	Risk Target & Year of Next Inspection	Tree Works	Work Priority
T3	Maple (Silver)	12.5	Mature	Subject to previous pruning	No Gross Defect Noted	This tree has been topped at 6m previously and the canopy has fully regrown. There is a genuine risk of sections of regrowth breaking out. The buildings do shelters the tree but cyclical reduction work should manage this structural defect. This appears in place with further reduction points high in the main canopy.	Medium (2018)	Crown reduce by 2-3m and repeat at 5 year intervals	12 months
T8	Judas Tree	6.8	Mature	No significant recent management	Gross Defect Noted	In significant decline with minimal foliage.	NA - tree to be felled	Remove and Replace	12 months
T13	Maple (Silver)	12.5	Mature	Subject to previous pruning	No Gross Defect Noted	This tree has been topped at 6m previously and the canopy has fully regrown. There is a genuine risk of sections of regrowth breaking out. The buildings do shelters the tree but cyclical reduction work should manage this structural defect. This appears in place with further reduction points high in the main canopy. Large surface roots visible tracking to down pipe/ drainage.	Medium (2018)	Crown reduce by 2-3m and repeat at 5 year intervals	12 months

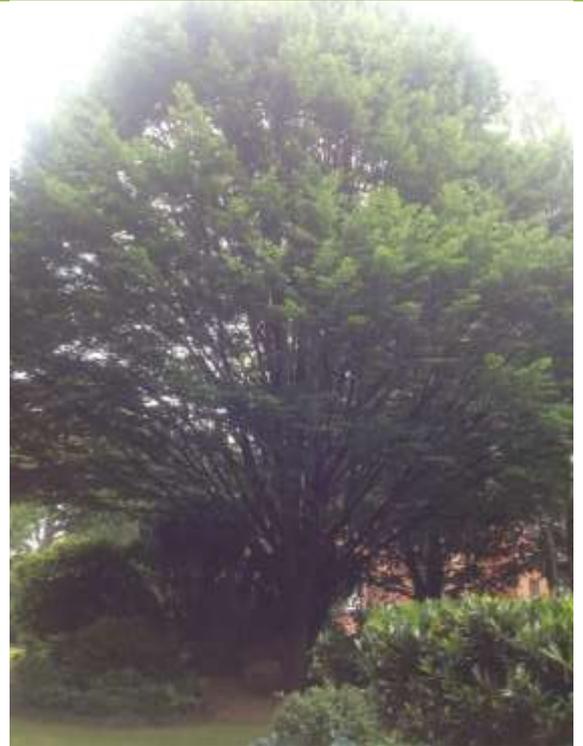
Tree No.	Species	Height (m)	Age Class	Past Management	Defects	General Comments	Risk Target & Year of Next Inspection	Tree Works	Work Priority
T5	Hornbeam (Fastigiata)	11.5	Mature	No significant recent management	No Gross Defect Noted	Good form for species. Minor bacterial canker at base with some necrotic bark but minimal evidence of decay.	Low (2020)	No works	NA
T6	Plum (Purple)	6.8	Mature	No significant recent management	No Gross Defect Noted	Canker wood/ graft growth at 2m but appears in good health.	Low (2020)	No works	NA
T7	Cherry	4.5	Mature	No significant recent management	No Gross Defect Noted	Some thinning of canopy evident and could be in slow decline. Small tree away from target areas.	Low (2020)	No works	NA
T8	Judas Tree	6.8	Mature	No significant recent management	Gross Defect Noted	In significant decline with minimal foliage.	NA - tree to be felled	Remove and Replace	12 months
T9	Plum (Purple)	6.8	Mature	No significant recent management	No Gross Defect Noted	Canker wood/ graft growth at 2m but appears in good health.	Low (2020)	No works	NA

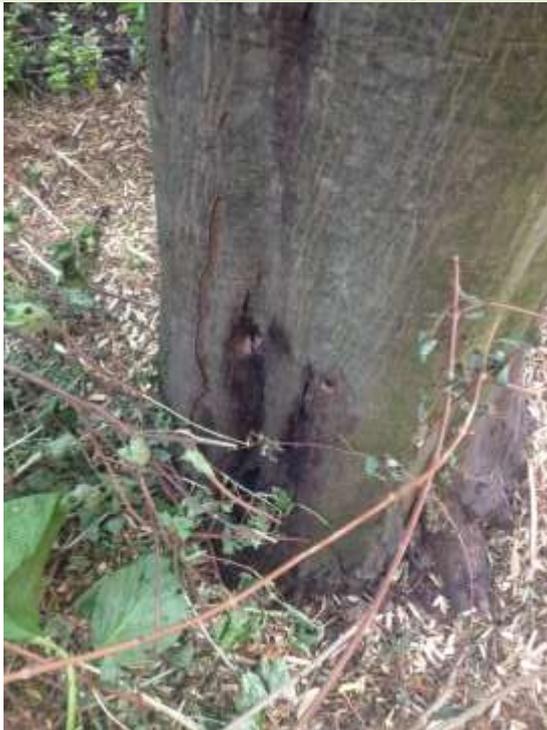
T5 Hornbeam showing bacterial activity at base

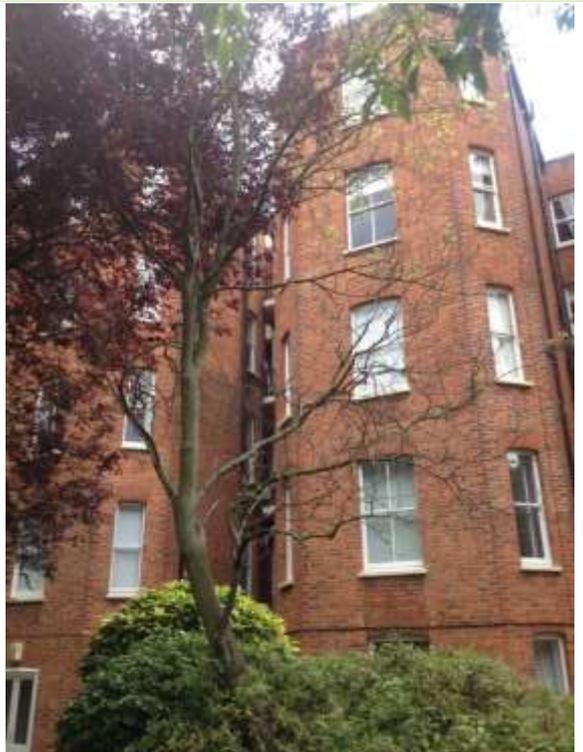
This tree is nearly dead and will not recover. It would be exempt from the need to make a formal application to the council before it is removed but 5 days' notice under Regulation 14 (1) C of the Town & Country Planning Act should be given prior to its removal.

T8 Judase Tree – nearly dead

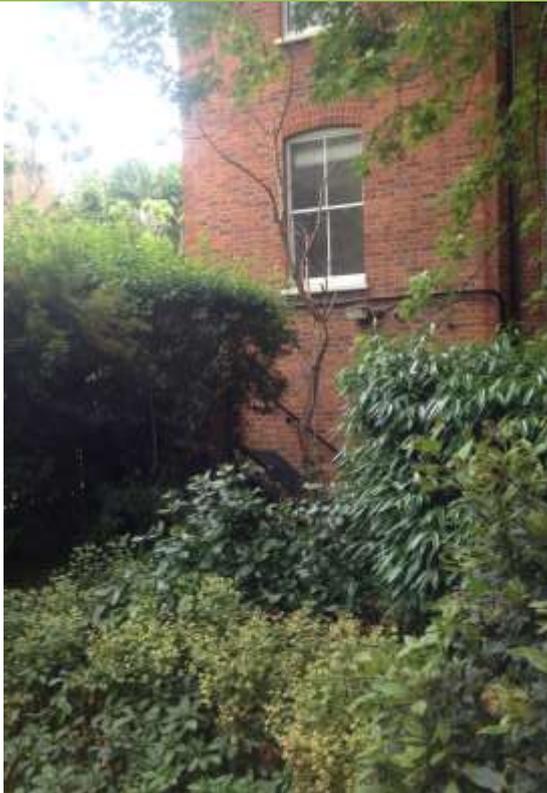
This tree is dead. It would be exempt from the need to make a formal application to the council before it is removed but 5 days' notice under Regulation 14 (1) C of the Town & Country Planning Act should be given prior to its removal.

T16 Laburnum - Dead

Tree No.	Species	Height (m)	Age Class	Past Management	Defects	General Comments	Risk Target & Year of Next Inspection	Tree Works	Work Priority
T16	Laburnum	3.4	Early-mature	No significant recent management	Gross Defect Noted	Dead	NA - tree to be felled	Remove and Replace	12 months

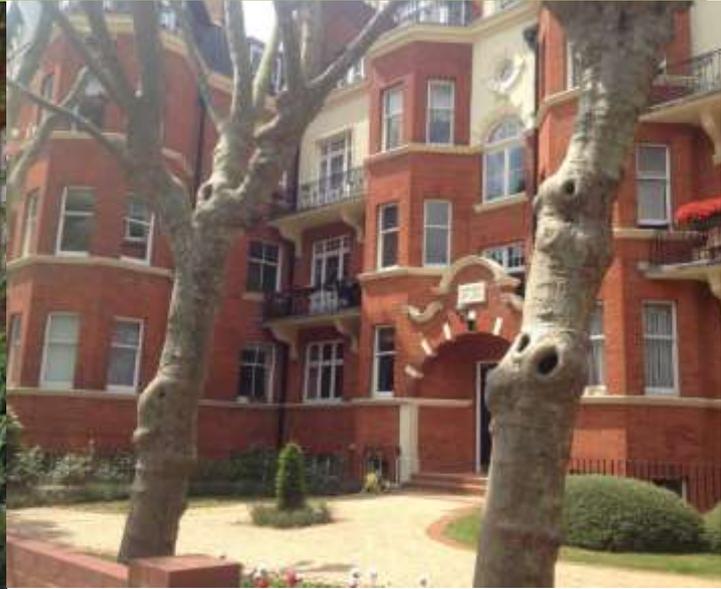
Example decay on main stems of London Plane trees

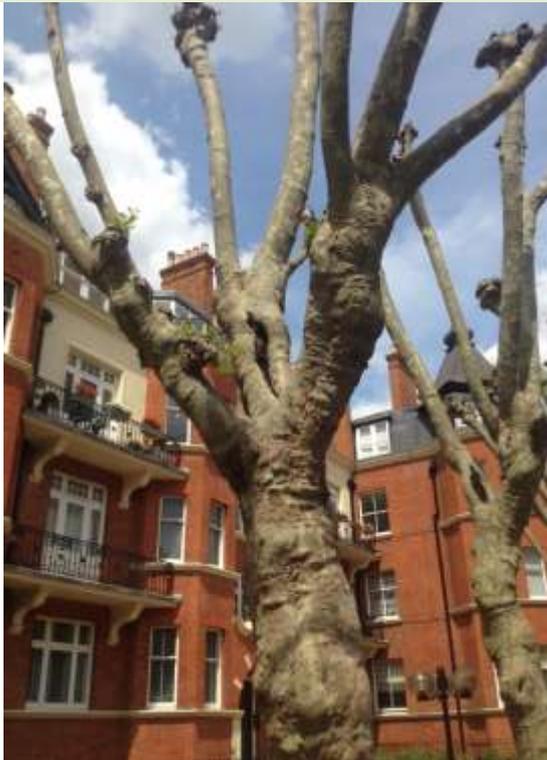
Example decay on London Plane

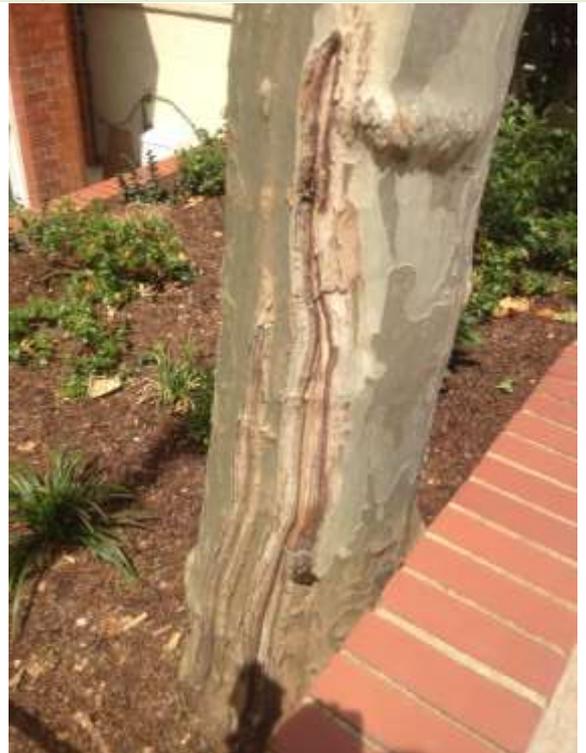
T32 London Plane – lower stem lesions

Tree No.	Species	Height (m)	Age Class	Past Management	Defects	General Comments	Risk Target & Year of Next Inspection	Tree Works	Work Priority
T32	Plane (London)	6.5	Mature	Managed as high pollard	No Gross Defect Noted	Subject to regular reduction work to remove 100% of canopy. Decay pockets evident. Regular reduction reduces strains on these defects and should be continued. Close to brick built boundary wall. Lesions on lower stem.	High (2016)	No works	NA
T33	Plane (London)	6.5	Mature	Managed as high pollard	No Gross Defect Noted	Subject to regular reduction work to remove 100% of canopy. Decay pockets evident. Regular reduction reduces strains on these defects and should be continued. Close to brick built boundary wall. Ivy establishing.	High (2016)	No works	NA
